Experimental Investigation of Lateral Cyclic Behavior of Wood-Based Screen-Grid Insulated Concrete Form Walls

John Stuart Garth

Master of Science
in
Civil and Environmental Engineering

Portland State University
2014

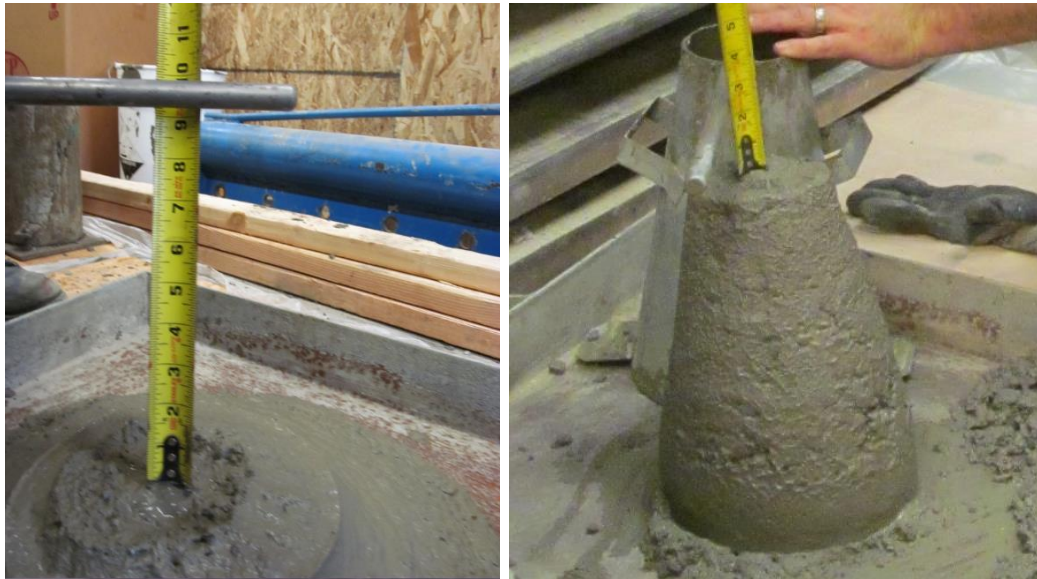
Figure 2-3: Slump tests for the first set (left) and second set (right) of walls.

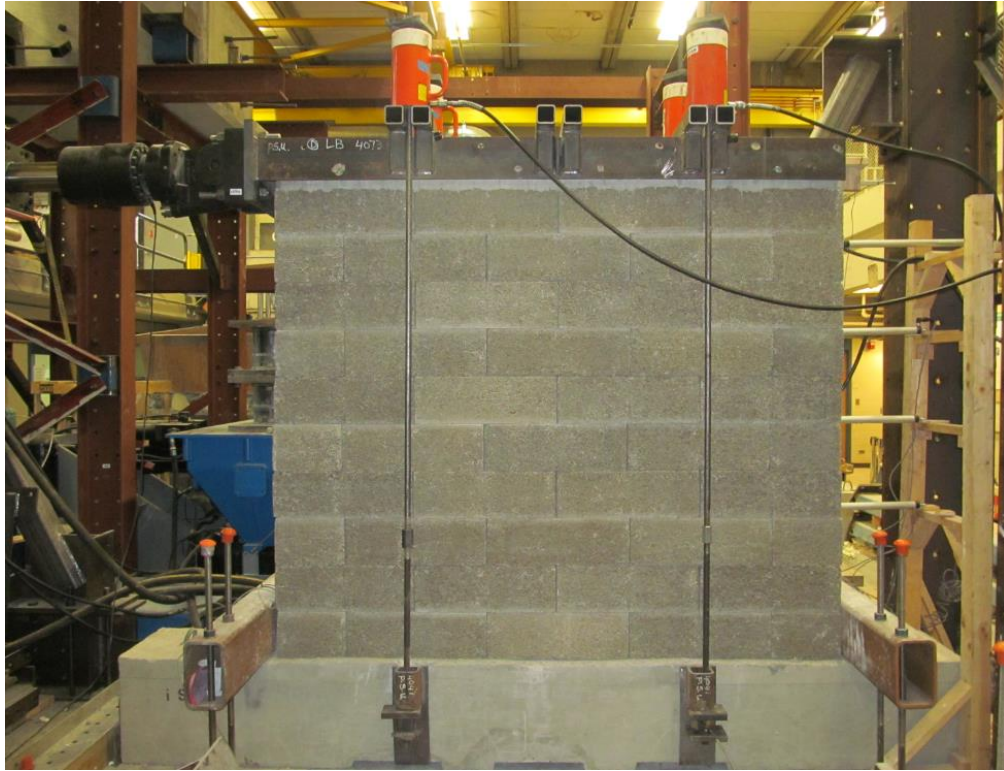
Figure 2-11: Long wall with second load beam and additional gravity load applied.

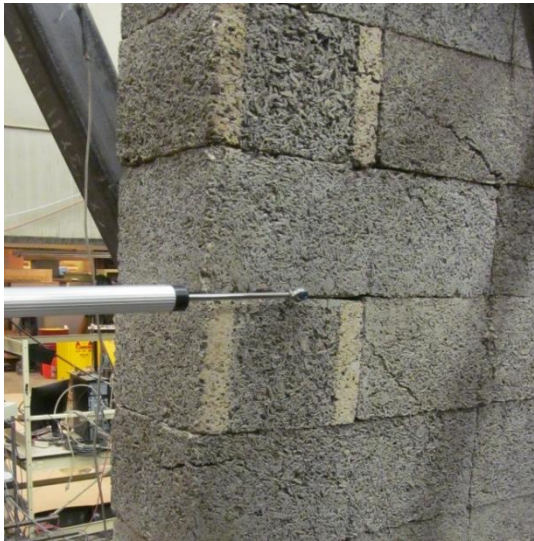
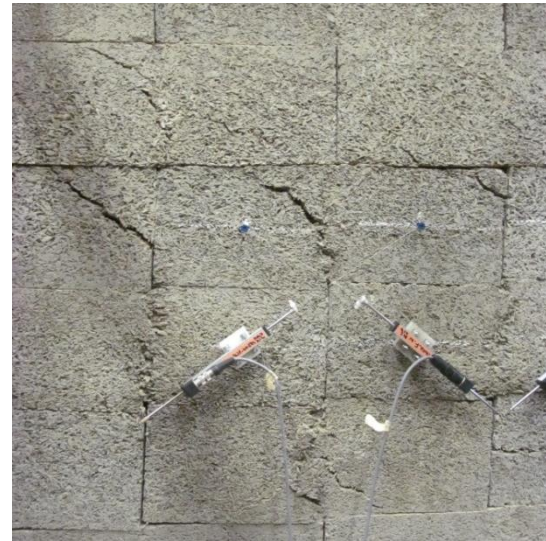
Figure 4-4: Cracking in the forms on the back side of specimen LWS.

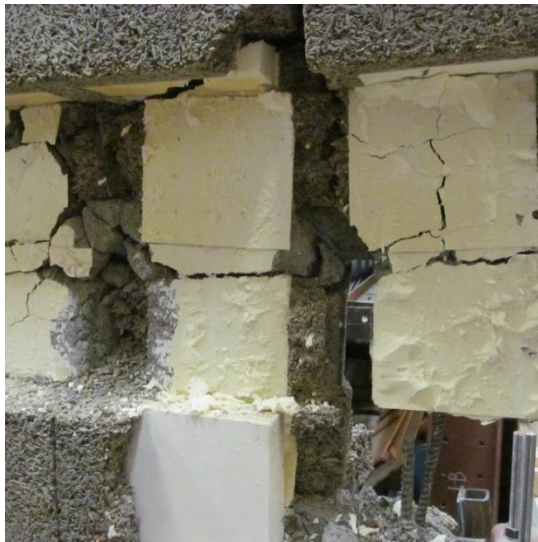
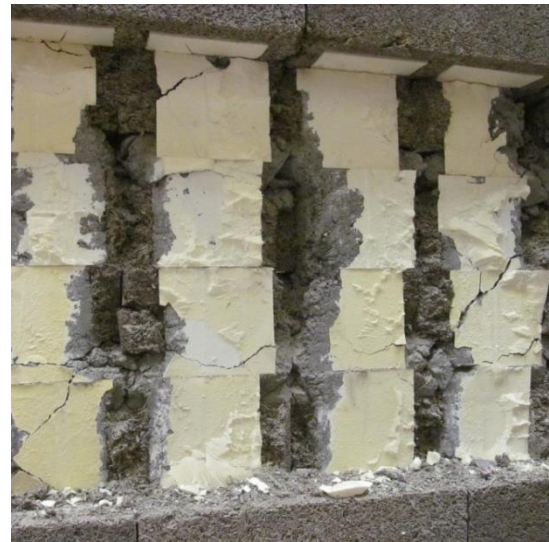
Figure 4-5: Walls LWA and LWS after testing sequence was completed.

LWS

LWA (Right End)

LWS (Middle)

(for both walls), which would be about 10 in above the lab splice. Wall deflection data for LWS showed that hinging occurred well below that region when the wall was displaced in the positive direction. When the wall was displaced in the negative direction, hinging appeared to occur 40 in above the foundation block, or where major flexural cracking was most apparent. The same data were inconclusive for wall LWA because of the end block (on the right, fifth from the foundation block) that popped out of place during the cycle sequence at 2.89% target drift, as can be seen in Figure 4-2. Figure 4-5 shows both walls after failure with wall forms removed from critical regions. While removing these wall forms, extra care was taken to not disturb the interior cores, but loose pieces of concrete were inevitable after the walls had been tested to failure.

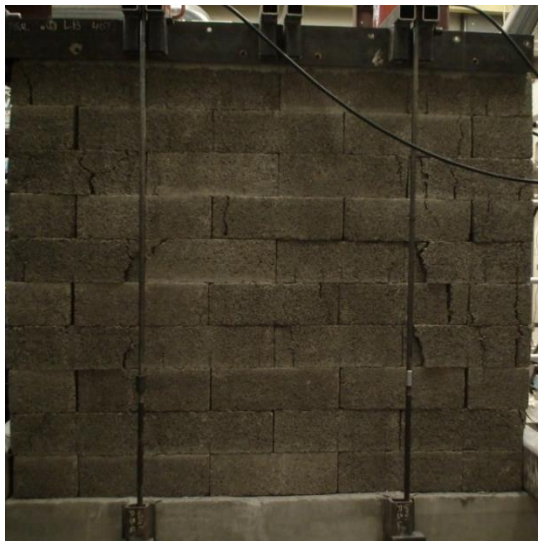
Figure 4-6: Progression of testing for wall LWG.

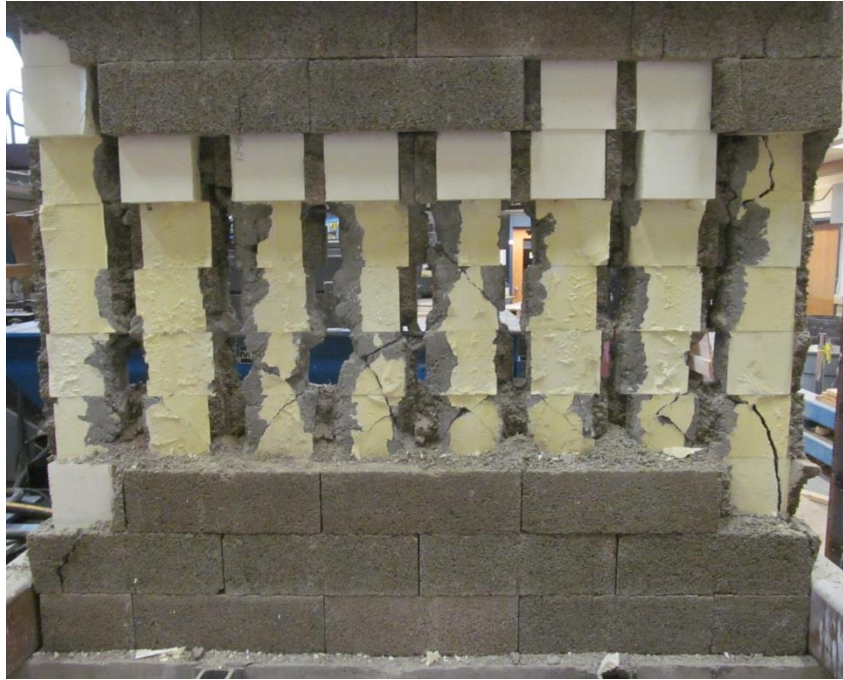
After testing was completed, the wall forms were removed from the specimen in order to inspect the damage incurred by the internal reinforced concrete grid. As was the case with the previous walls, the interior horizontal cores (i.e., the three middle rows) had all been either completely or almost completely sheared off. Unlike the other walls, there was no major flexural cracking in the vertical cores, not even around the lap splice. The vertical cores did experience significant diagonal shear cracking and some vertical cracking that seemed to propagate from shear cracks. Figure 4-7 shows a picture of the wall upon inspection. The latter cracking phenomenon is visible in the upper and lower portions of the vertical core that is furthest to the right.

Figure 4-7: Specimen LWG after loading protocol.

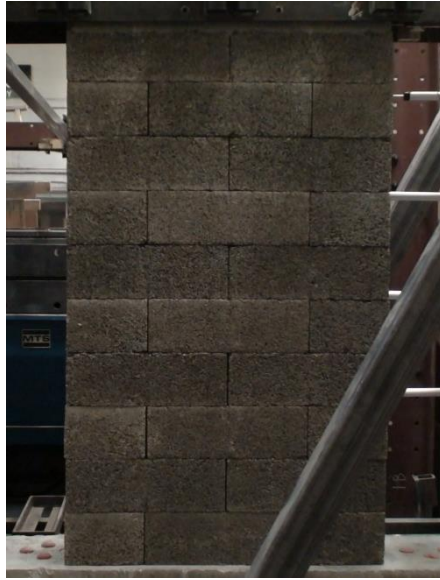
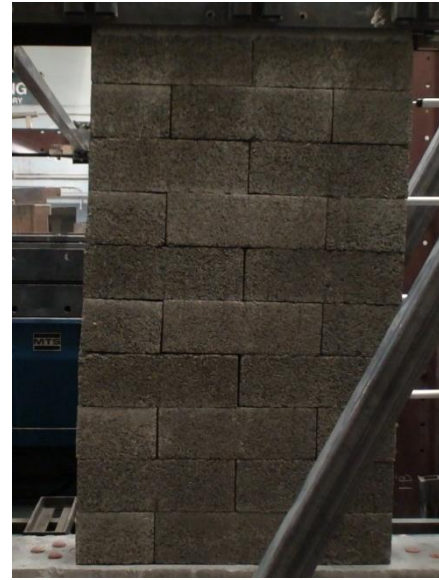
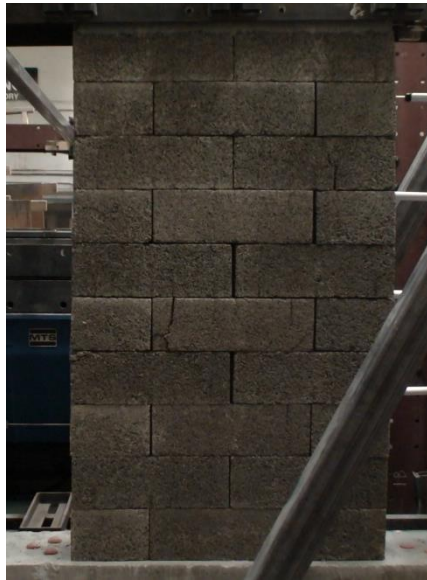
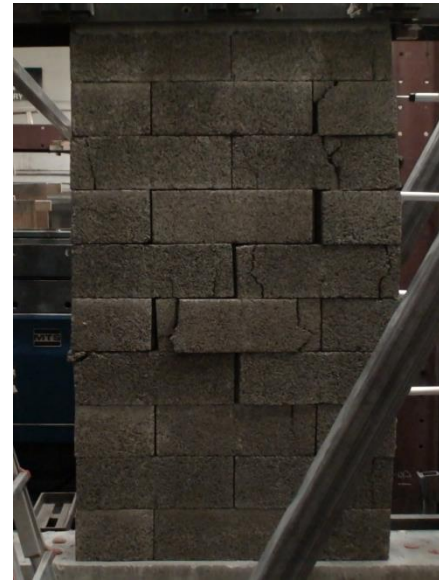
Figure 4-11: Specimen SWS during and after in-plane loading protocol.

(a) 1.05% Drift

(b) 2.89% (+) Drift

(c) 3.47% Drift

(d) 4.05% Drift

Figure 4-11 shows the progression of damage to the baseline short wall. Specimen SWS displayed no obvious visual damage until reaching the cycle sequence for 1.05% target drift. No cracking was noticed during this sequence, but slight separation of the end

blocks, at about mid-height, was observed in both directions of load application. Some horizontal cracks were noticed in the end blocks on both sides of the wall during the 1.48% target drift sequence. Diagonal separation – which was discussed above and is clearly visible in Figure 4-11(b) – also began to occur during this phase of testing. Some faint shear cracks were also visible on the back side of the wall at about the height of the lap splice. Each of these issues continued to develop and propagate over the cycle sets for 2.07% and 2.89% drift. The peak load resistance of the wall was reached during the 2.07% drift sequence and the 2.89% sequence for the forward and reverse directions, respectively. Vertical cracks began appearing on the front side wall forms after this latter sequence. After the 3.47% drift cycles were imposed upon the wall, some of these vertical cracks had proliferated to such a degree that the wall forms were protruding from the wall. This behavior – see Figure 4-11(c) and (d) – only worsened during the last set of cycles, which had a target drift of 4.05%.

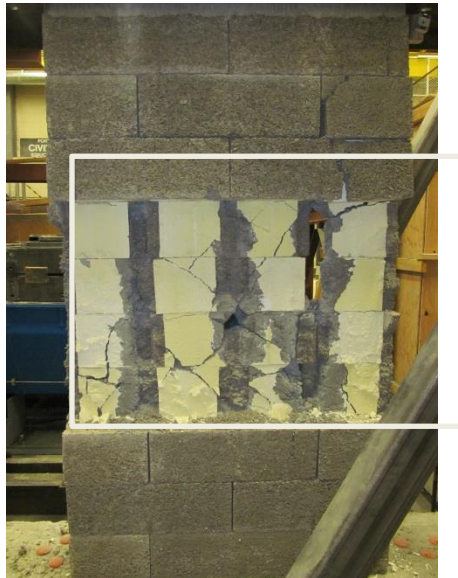
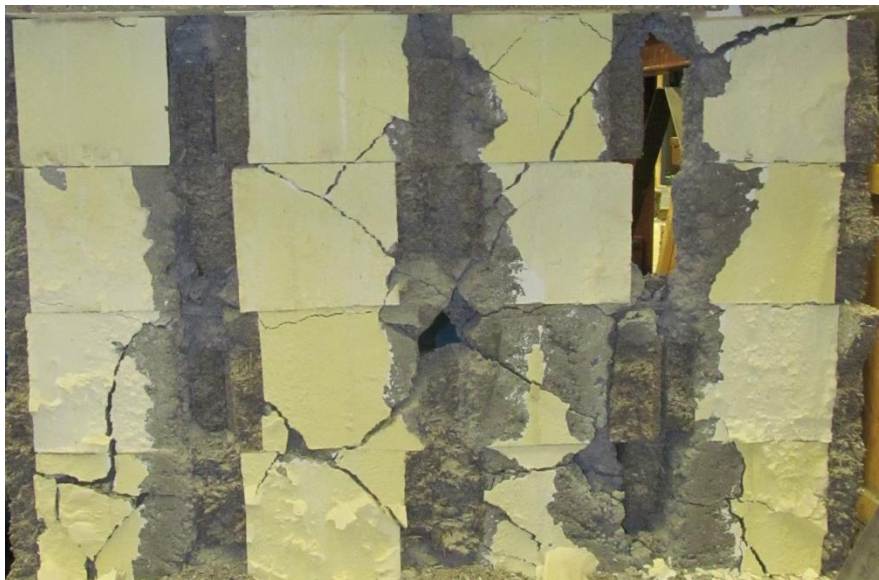
cracks. Figure 4-12 shows the specimen with wall forms removed so that the internal concrete screen-grid could be examined.

Figure 4-12: Specimen SWS with wall forms removed for inspection.

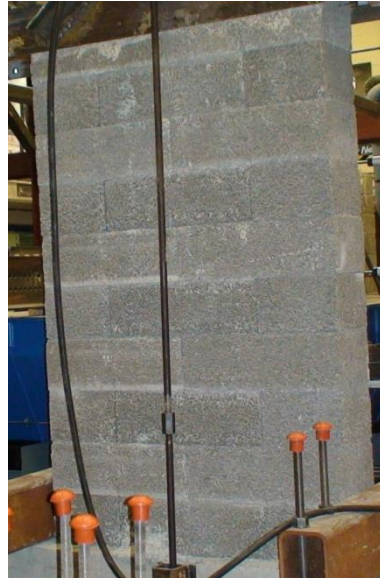
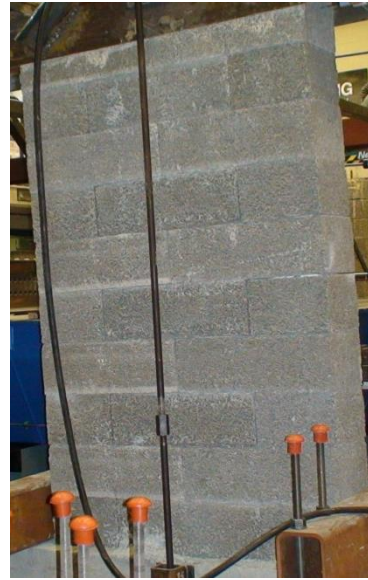
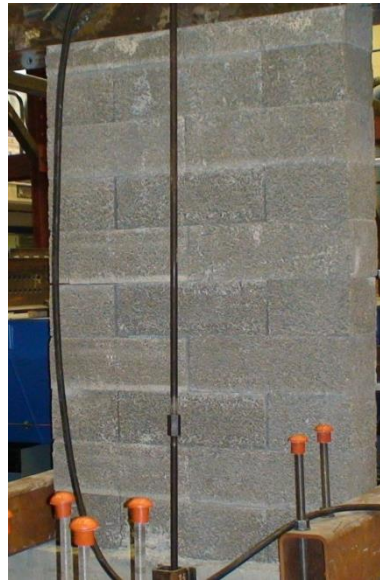
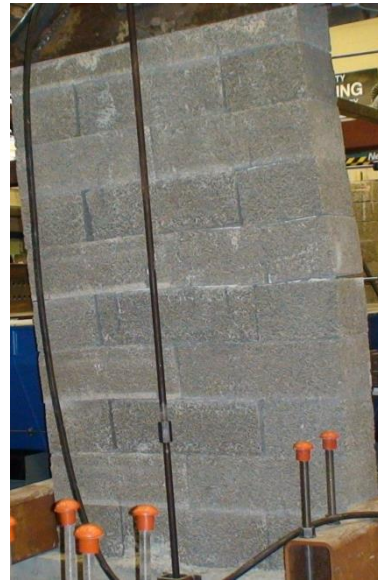
Figure 4-13: Progression of test on specimen SWG.

(a) 2.07% Drift

(c) 2.89% (-) Drift

(b) 4.05% (+) Drift

(d) 5.67% (-) Drift

The short wall that was subjected to additional axial load did not display any signs of damage until the protocol reached a target drift of 1.48%, when the tension side end blocks began to separate in both directions of loading. The progression of the damage incurred by the specimen is displayed in Figure 4-13. This separation continued to increase over the next several sets of cycles, but no other damage was noticed until the target drift had reached 3.47%. At this drift, vertical and diagonal cracks began to appear in the forms on the back side of the wall. These cracks seemed to have been initiated in areas where horizontal cores were located. Some vertical cracks had also developed in the end blocks on the front side of the wall at this stage in the loading protocol. The cracking and separation only became more pronounced until the last set of cycles, when the front side of the wall forms started detaching from the wall. The target drift for this set of cycles was 5.67%.

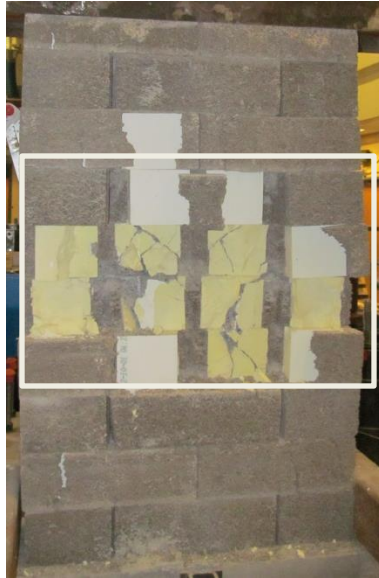
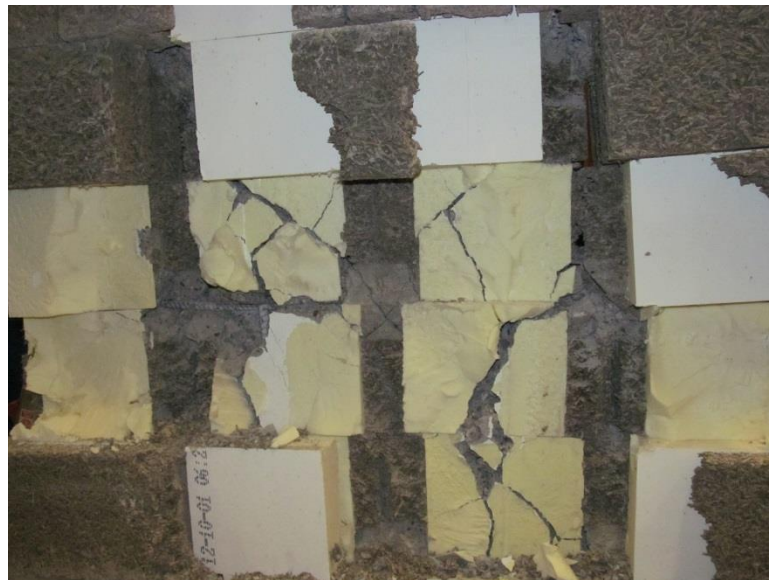
The end blocks also had some flexural cracking around the lap splice, which was 40 in above the foundation block for this specimen.

Figure 4-14: Specimen SWG with wall forms removed for inspection.
